Corrosion failure analysis of hearing aid battery-spring contacts

Gudla, Visweswara Chakravarthy; Ambat, Rajan

Published in:
Engineering Failure Analysis

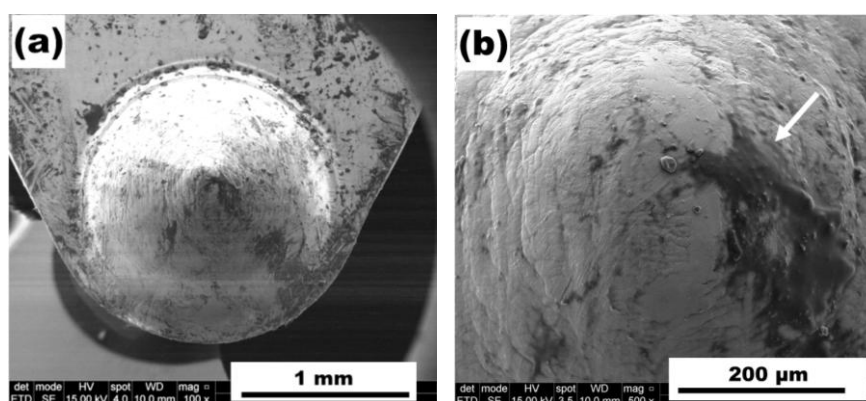
The Au plated *Contact-1* surface shown in Figure 3 displayed no features that correspond to general wear or corrosion of the contact surface. The Au plating was found to be intact, however presence of organic compounds as contamination was observed. The EDS analysis (see Table 1) of this contamination shows presence of high amounts of C, F and Si in addition to traces of K and Na. In contrast, the dome surface of *Contact-2* clearly displayed delamination of the applied Au plating at the contact point as seen in Figure 4. In addition, the exposed substrate displayed wear track morphology. This is due to the repeated wiping motion that occurs while changing the battery during the service of the device. Organic

Figure 3: Secondary electron image showing: (a) hemispherical dome *Contact-1* and (b) contamination at the *Contact-1* surface.

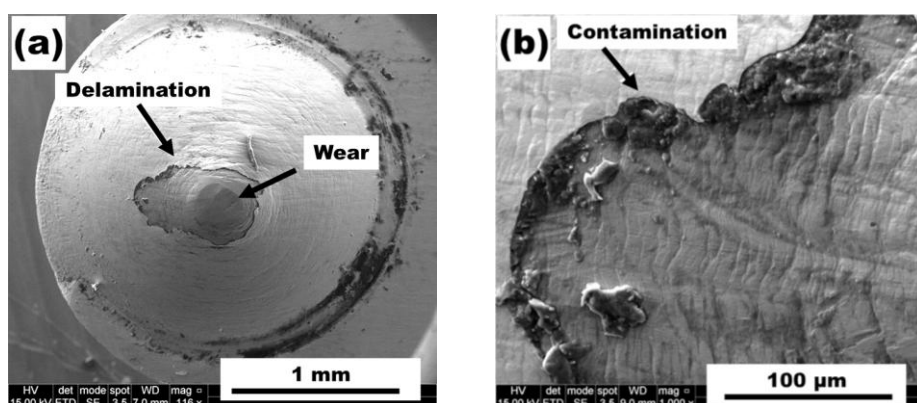
contamination containing C, O, F, Al, and Si was detected on the exposed substrate surface of the contacts (see Table 1).

Figure 4: Secondary electron image showing: (a) delamination of Au coating on *Contact-2* and (b) contamination on the exposed substrate in *Contact-2*.

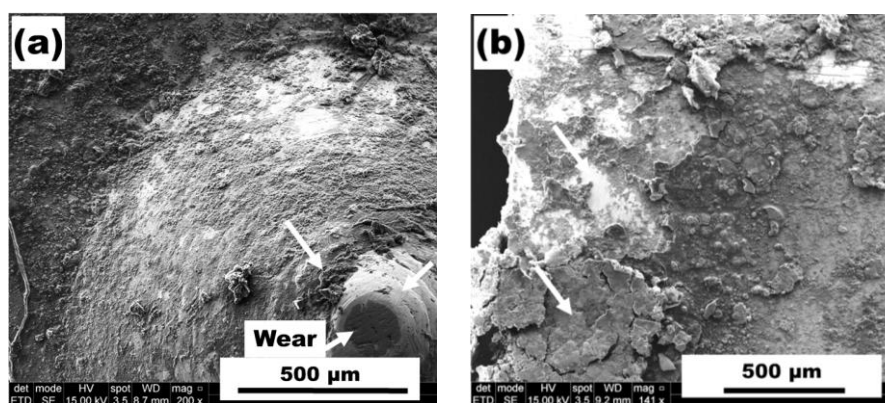
The *Contact-3* surface showed no delamination of the Au plating, but displayed wear out of the Au plating resulting in exposure of the underlying substrate (see Figure 5). Severe organic contamination was observed on the hemispherical dome. The EDS analysis showed that it consisted of C, O, Na, Mg, Al Si, S, Cl in addition to the elements from substrate material which is a Ni-based material (similar composition for *Contact-2* substrate, see Table 1). In addition, several locations displayed features corresponding to corrosion and associated corrosion products as shown in Figure 5 (b). Heavy corrosion products with mud crack morphology were observed. In order to get a better overview of the nature and composition of the corrosion products, an EDS elemental mapping was carried out on the area shown in Figure 5 (b) (see Figure 6).

Figure 5: Secondary electron image showing: (a) wear of Au coating on *Contact-3* with exposed substrate and severe contamination on the dome, and (b) severe corrosion of the Au coated spring material in *Contact-3*.

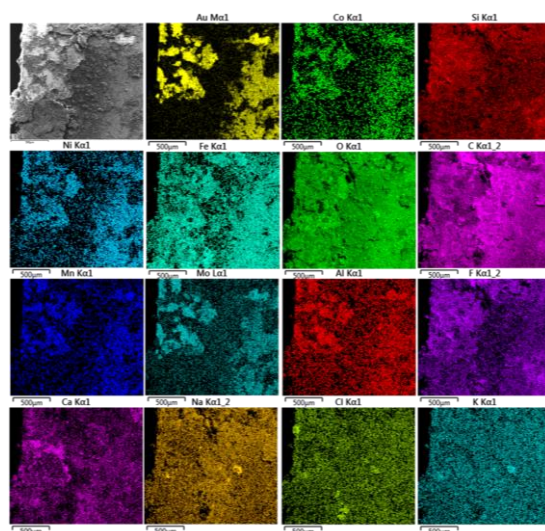
The EDS elemental maps for corroded region on *Contact-3* (shown in Figure 5 (b)) are shown in Figure 6. The bright appearing surface in the secondary electron image corresponds to the Au plating which also shows presence of Co. Cobalt is generally added to Au plating baths to obtain hard Au coating with better mechanical properties compared to the pure Au which is softer [11]. In addition to Ni from the substrate, Fe also is present, which is an alloying element for the Ni-based substrate alloy. However, the distribution of Fe does not follow that of Ni. A closer observation at the distribution of Fe shows that it follows the distribution of O suggesting the presence of Fe-O based phases like Fe_2O_3 or Fe_3O_4 (corrosion product, Rust). In addition, the maps for C, Si, and F follow each other and this is attributed to the organic contamination that has been observed on the surfaces of various contacts as

discussed earlier. Other elements such as Na, K, Al, and Ca along with Cl are detected, which suggest the presence of salts and silicates arising from the atmosphere in the form of mist, dust particles and/or from human perspiration.

Figure 6: Secondary electron image and EDS elemental maps of the corroded surface region on *Contact-3*.

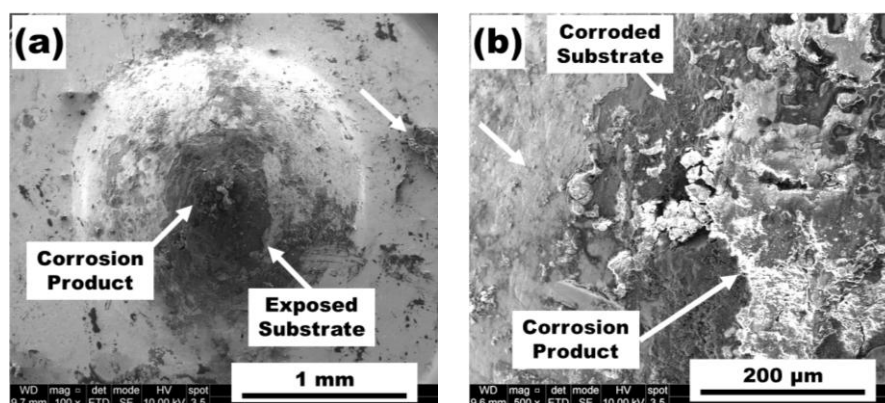
Figure 7 shows the corrosion and contamination on *Contact-4* surface. Corrosion products were observed at the contact surface and in addition, crystals of salts based on chlorides of Na and K were detected as seen in Figure 7 (c) (see Table 1 for composition). The Au plating appeared to be intact all over the surface of the contact with exception to the contact point as seen in Figure 7 (b). However, a closer look at the surface morphology of the Au reveals that there are a huge number of pores in the Au surface (see Figure 7 (d)). The origin of these pores can be attributed to either inherent porosity in the Au plating or due to corrosive attack by the salts that are found on the contact surface.

electrolyte to the underlying not so noble metals like Ni (see Figure 7 (d)) causing 'pore corrosion'. This causes corrosion of the underlying material that is accelerated due to the galvanic coupling between a small active metal surface (anodic site) at the bottom of the pore and a high surface area of noble metal (cathodic sites). Severe localised corrosion of the underlying metal results in volume expansion and forms halos around the pinhole on the surface of the gold, and in extreme cases total delamination of the top gold layer [10,27,28]. The presence of corrosion under the top gold layer in Figure 8 is a manifestation of severe underlying metal corrosion due to pores in the gold layer.

Figure 7: Secondary electron image showing: (a) delamination of Au coating and corrosion on *Contact-4*, (b) corrosion products, corroded substrate and contamination on the exposed substrate region in *Contact-4*, (c) crystals of salt on the *Contact-4* surface and (d) pores in the surface of the Au plating.

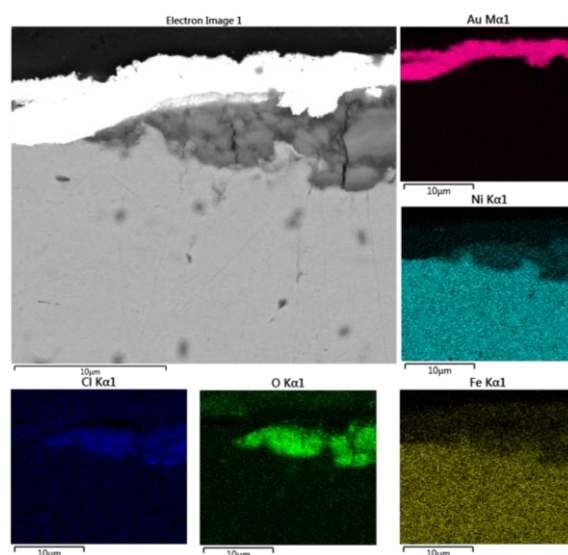
Figure 9: EDS elemental maps of the corroded region in the Ni substrate below the Au plating showing oxides and chlorides as corrosion products.
